Supplement of

Ecological restoration and soil improvement performance of the seabuck-thorn flexible dam in the Pisha Sandstone area of Northwestern China

F. S. Yang et al.

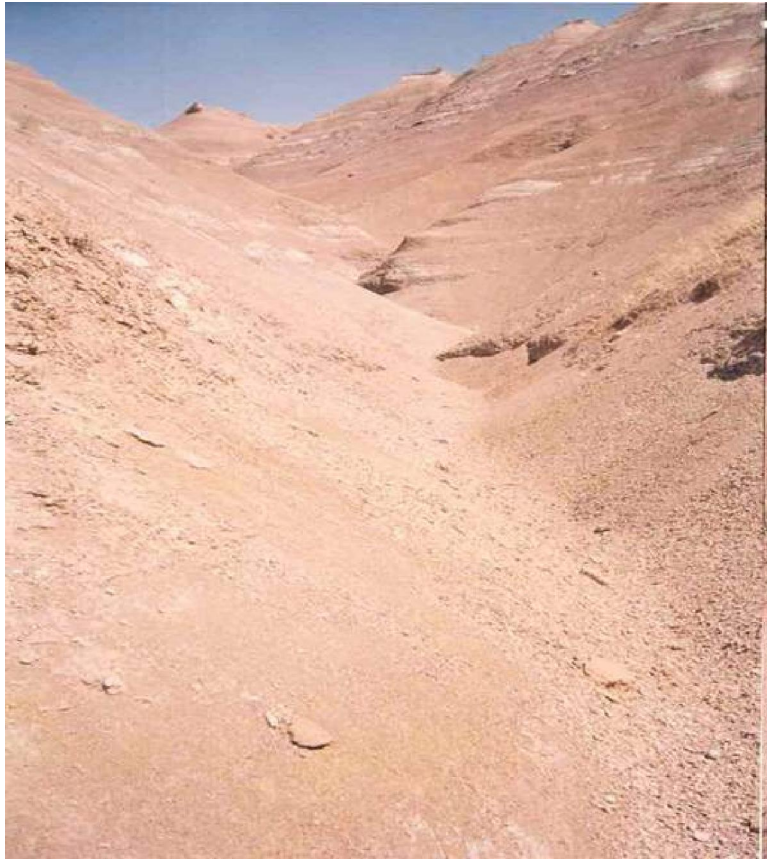
Supplemental figure 1. Gully head of the studied gully (in 1994) (Bare gully, very poor ecosystem)

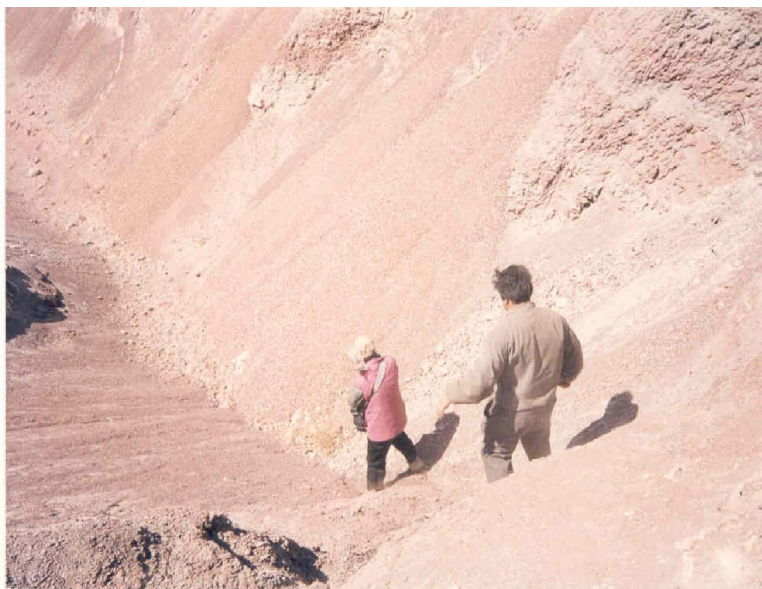
Supplemental figure 2. Upper reach of the studied gully (in 1994) (Bare gully, very poor ecosystem)

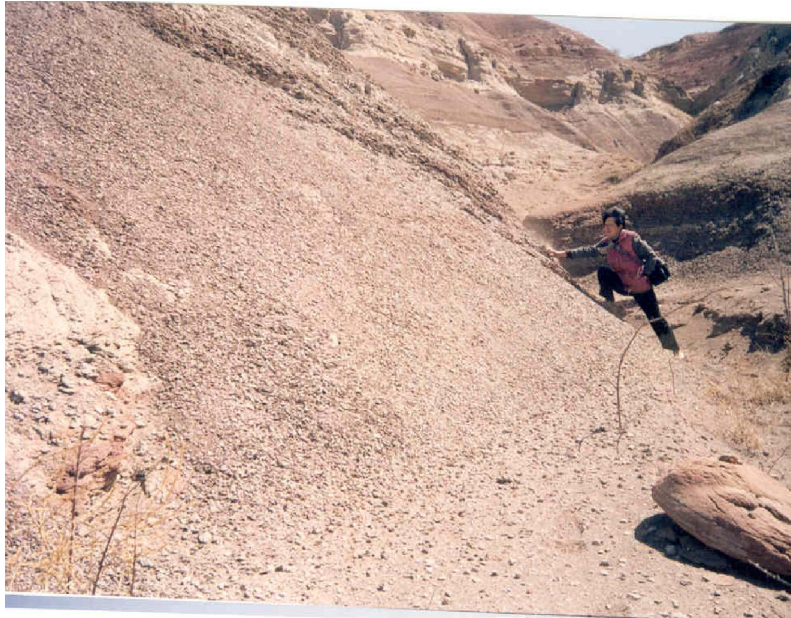
Supplemental figure 3. Middle reach of the studied gully (in 1994) (Bare gully, very poor ecosystem)

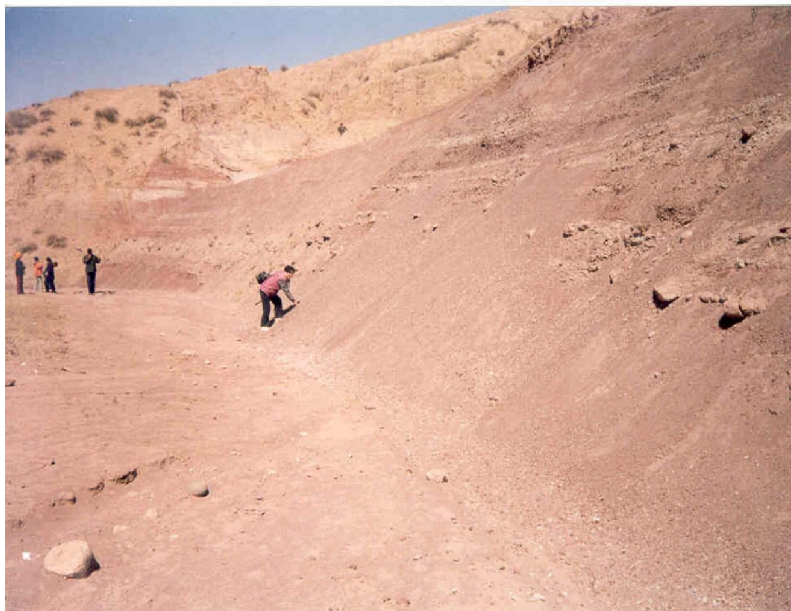
Supplemental figure 4. Lower reach of the studied gully (in 1994) (Bare gully, very poor ecosystem)

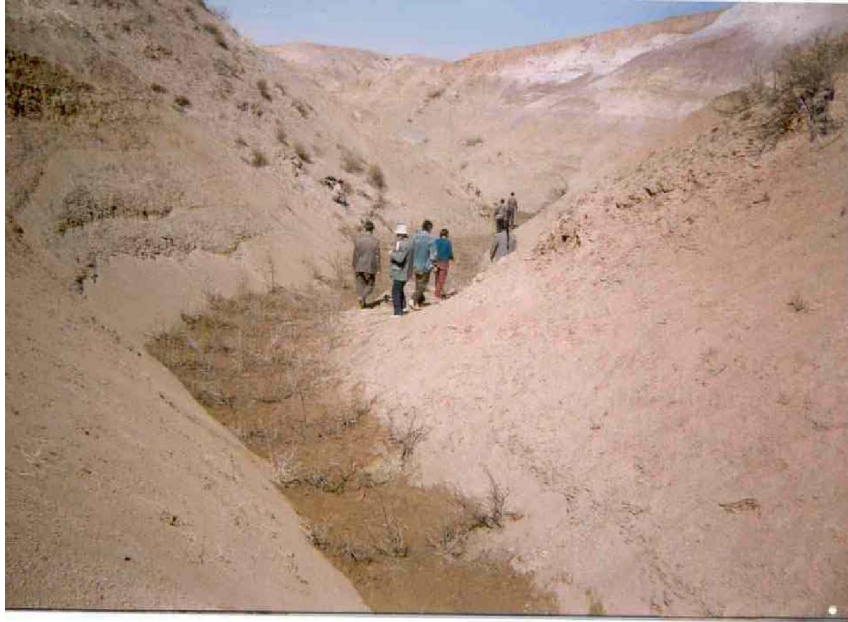
Supplemental figure 5. Planting of the SFD on the upper gully of the studied gully (in spring 1996)

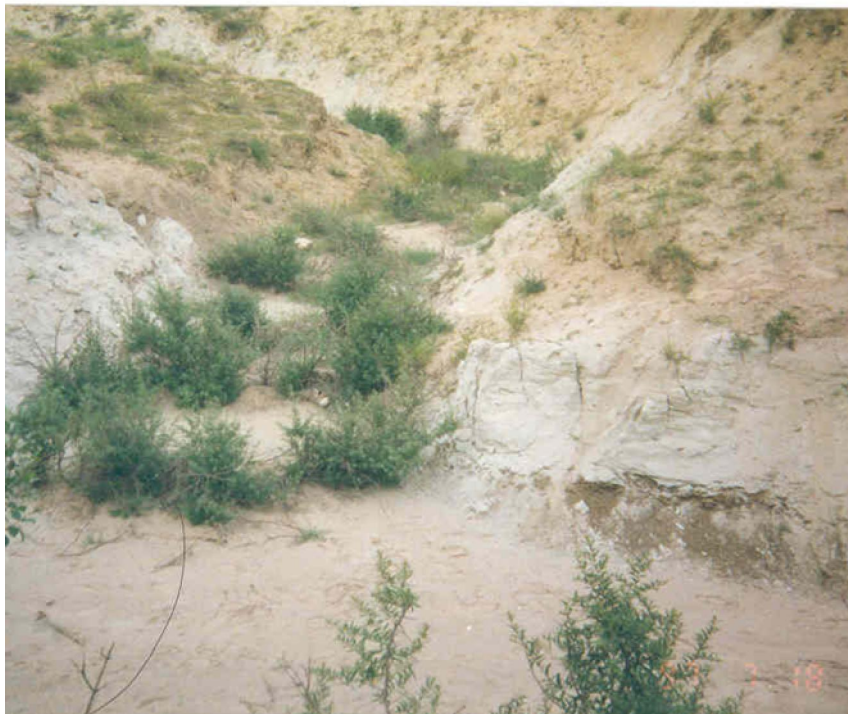
Supplemental figure 6. Growth of the SFD in spring 1997. (initial state of restoration of ecosystem)

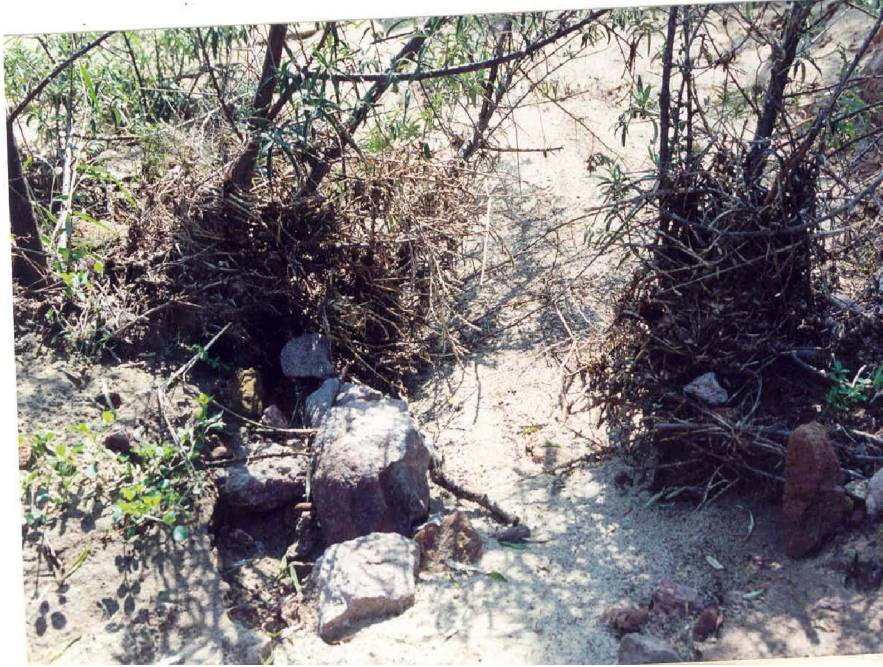
Supplemental figure 7. The size-bigger Pisha Sandstone trapped by the SFD after flood in 2000 (four years after)

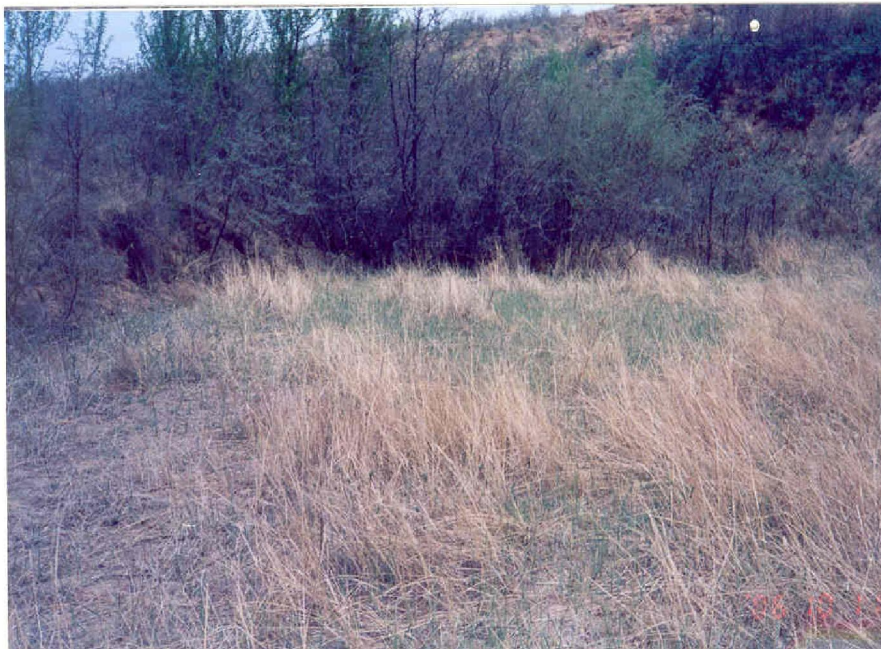
Supplemental figure 8. Growth of the SFD after nine years (in 2005) (good ecosystem restored)

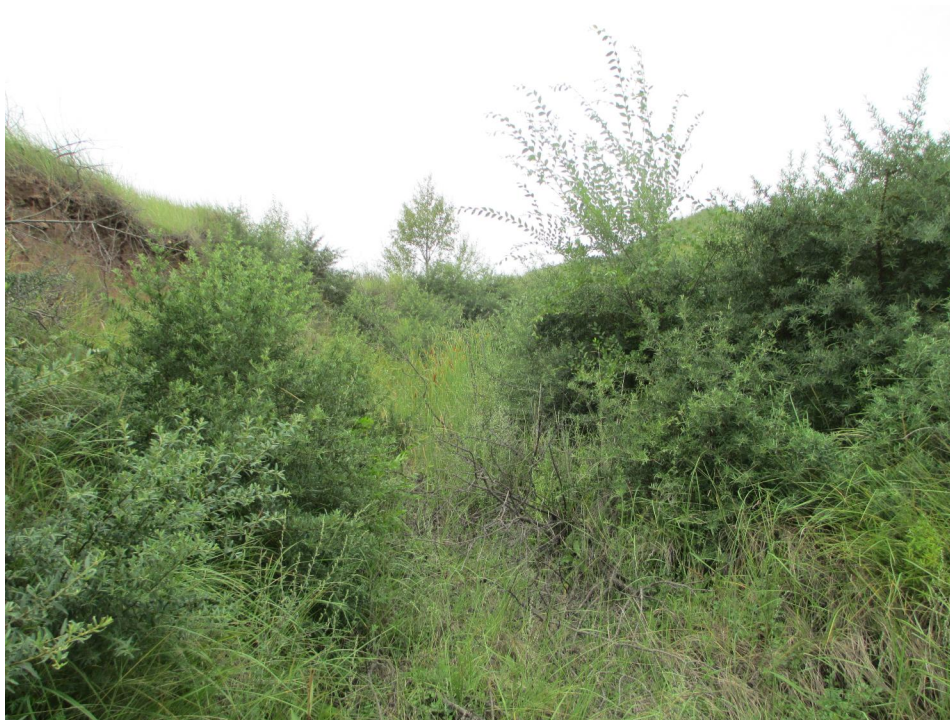
Supplemental figure 9. Present ecosystem of the studied gully (on August 15, 2014, very good ecosystem restored)

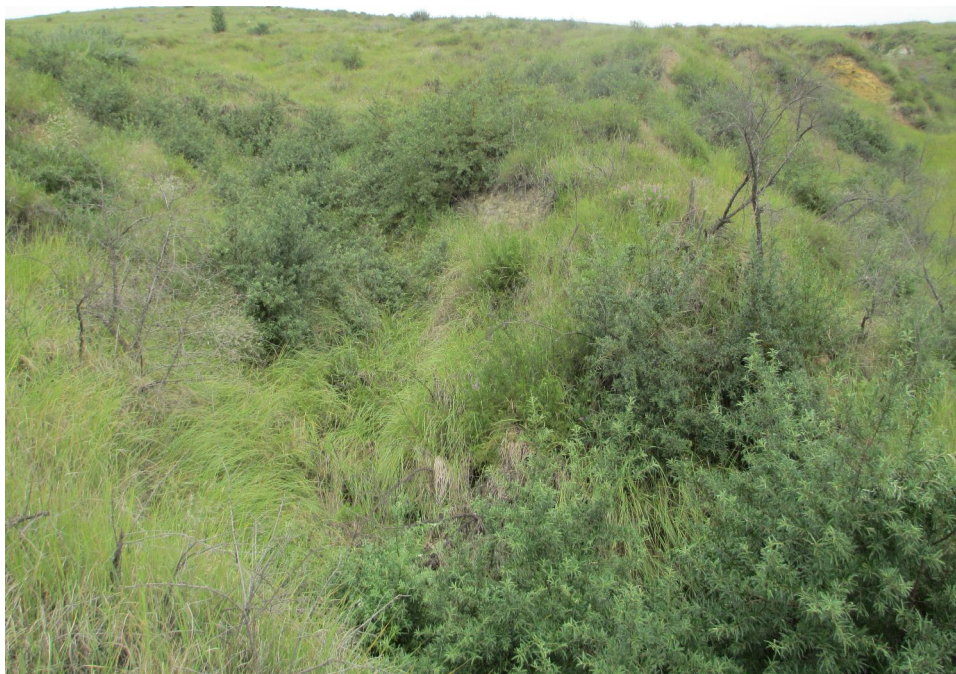
Supplemental figure 10. Present ecosystem of the studied gully (on August 16, 2014, very good ecosystem restored)
