Soil contaminations in landfill: a case study of the landfill in Czech Republic

D. Adamcová¹, M. D. Vaverková¹, S. Bartoň², Z. Havlíček³, and E. Břoušková³

Received: 29 September 2015 – Accepted: 30 September 2015 – Published: 23 October 2015

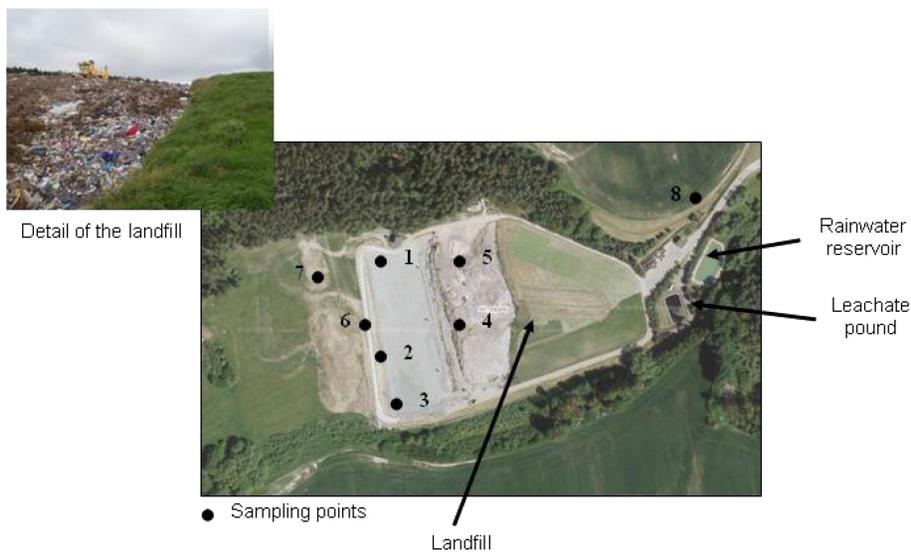
Figure 1. Map of Štěpánovice landfill and sampling points.

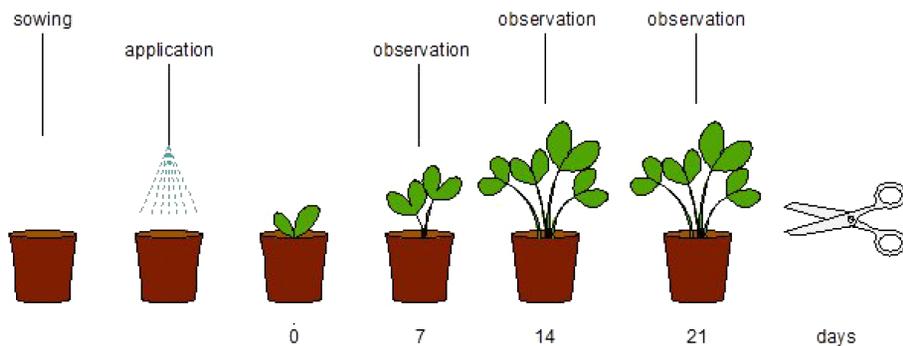
Figure 2. Layout of the phytotoxicity test.

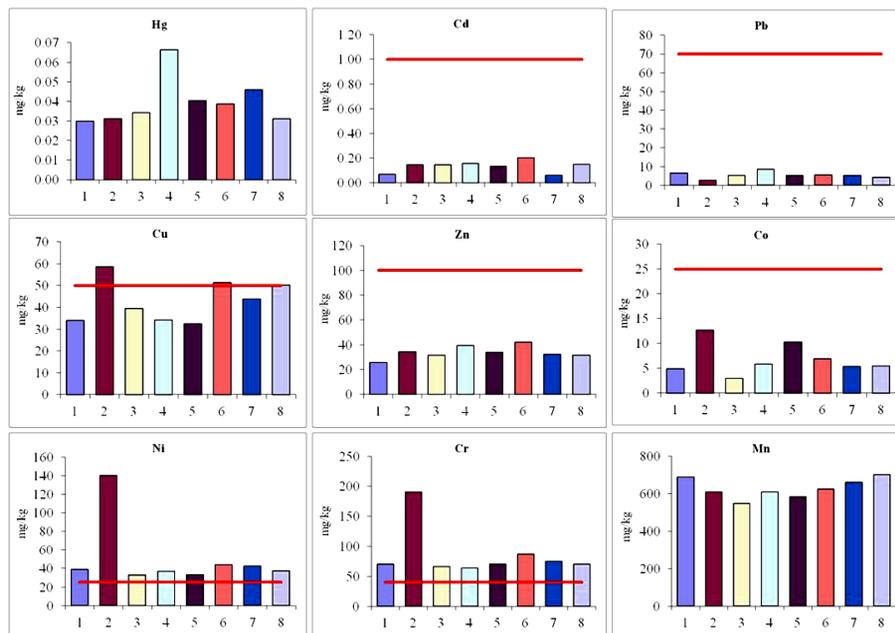
Figure 3. Content of heavy metals in examined soil samples. Mn, Hg – no threshold values are set in the Decree No. 13/1994 Coll.

in legislation, but values have been determined for the needs of the landfill operator. For heavy metals Cr, Cu, and Ni some samples exceeded the threshold values, namely sample 2, which attained the highest values of all the samples tested for Cr, Cu and Ni. For Cr and Ni the values were several times higher than values of the other samples.

After sample 2, the second highest values for Cr, Cu, and Ni showed sample 6 and also sample 7, this one particularly for Cr and Ni. Both of these samples exceeded the set limits, but their measured values were not as high as in the case of sample 2.

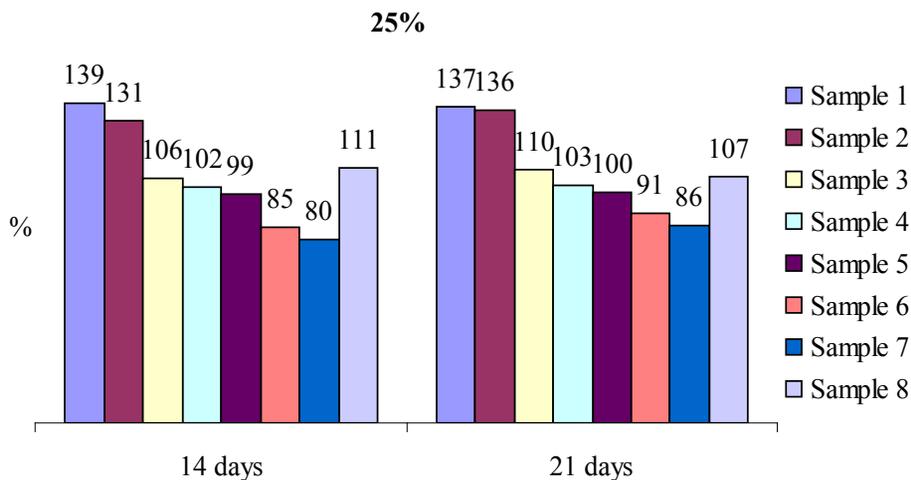
Figure 5. Comparison of the germination capacity at a concentration of 25 %.

An increase in plant biomass was observed in plants growing on plates with soil samples from the landfill body and its vicinity, but no changes in appearance, slow growth or necrotic lesions appeared. Ecotoxicity tests show that tested soils (at a concentration of 50 %) collected from the landfill body, edge of the landfill body and its vicinity reach high percentage values of germination capacity of seeds of white mustard (101–137 %). At a concentration of 25 %, tested soil samples exhibit lower values of germination capacity; in particular samples 3 to 8, yet the seed germination capacity in all 8 samples of tested soils range between 86 and 137 %.

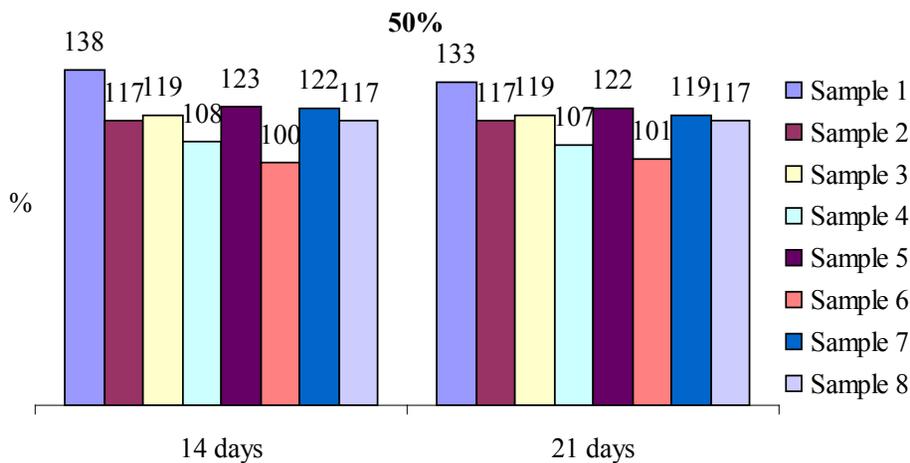
**Figure 6.** Comparison of the germination capacity of soil samples at a concentration of 50%.

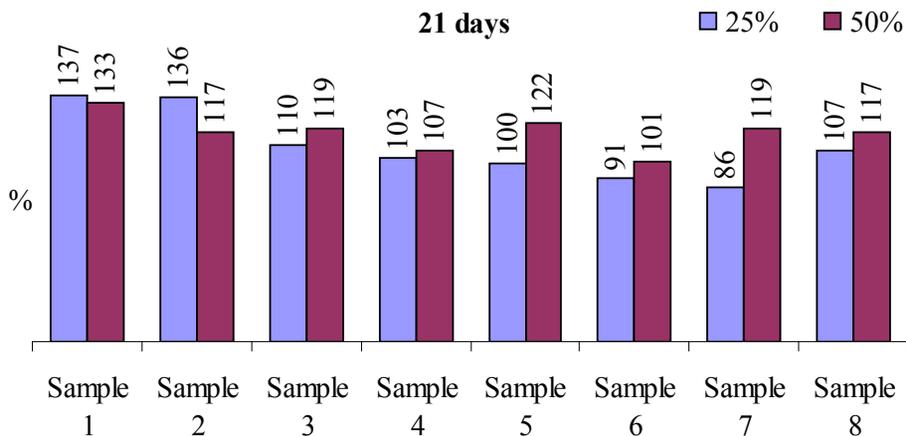
Figure 7. Results of germination capacity of white mustard seeds (at concentrations of 25 and 50%).

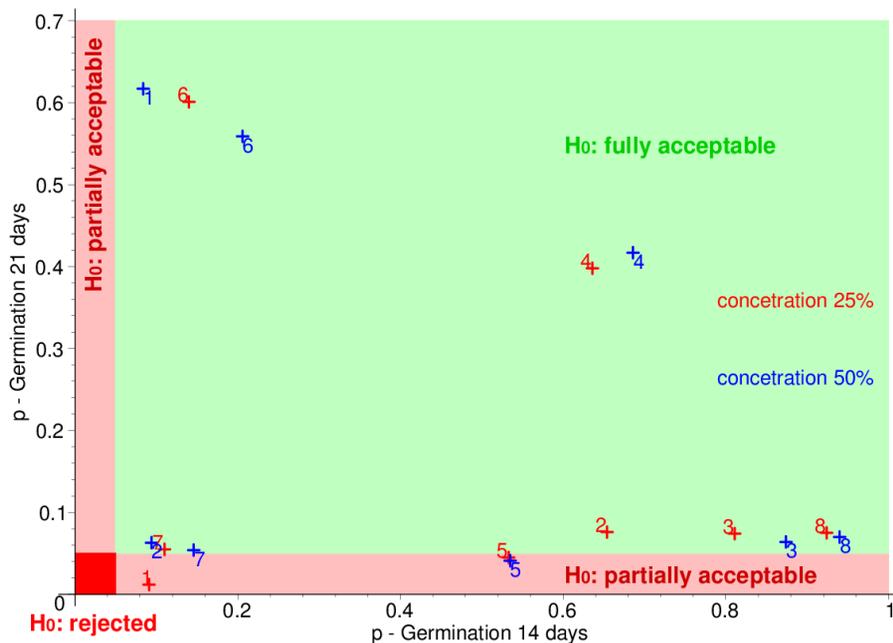
Figure 8. The values of p factor (ANOVA).
